Manhole Inspection Summary

Manhole # S15I__013MH

Inspection ☐ Is Incomplete Rating: **3) Fair**

Location Address: **2 franklintown rd**

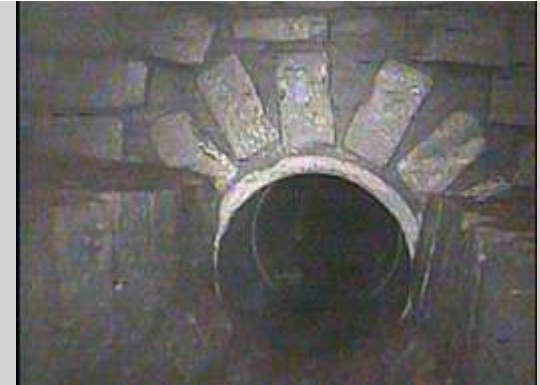
12 O'Clock Outflow

8 in. Circular Gravity Sewer
Pipe Out @ 12 OClock

Pipe Height: **8.4** (in.) Rod and Bar (Angled)
Pipe Material: **Clay** ☐ Pipe Lined
Invert Depth: **13.08** (ft.) Flow Characteristics: **Slow**
Deposits: ☒ None ☐ Mud ☐ Sludge ☐ Debris ☐ Grease
Silt Depth: **0** (in.) Deposits Extent:
Infiltration: **None** Pipe Seal Cond: **Sound**

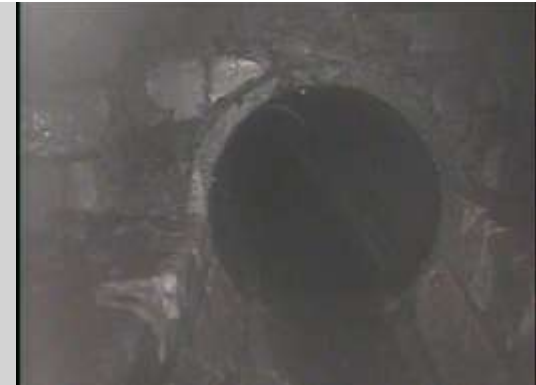
5 O'Clock Inflow

8 in. Circular Gravity Sewer

Pipe In @ 5 O'Clock

Pipe Height: **8.4** (in.) Rod and Bar (Angled)

Pipe Material: **Clay** ☐ Pipe Lined

Infiltration: **None** Pipe Seal Cond: **Sound**
